International Journal of Pressure Vessels and Piping

Specifics of diagnostics and investigation of material properties in pipes with planar defects

Dmitrii Zhukov^{a,b,c}, Sergey Konovalov^{a,c,d,*}, Danhe Chen^a, Alexey Melnikov^c, Irina Panchenko^d

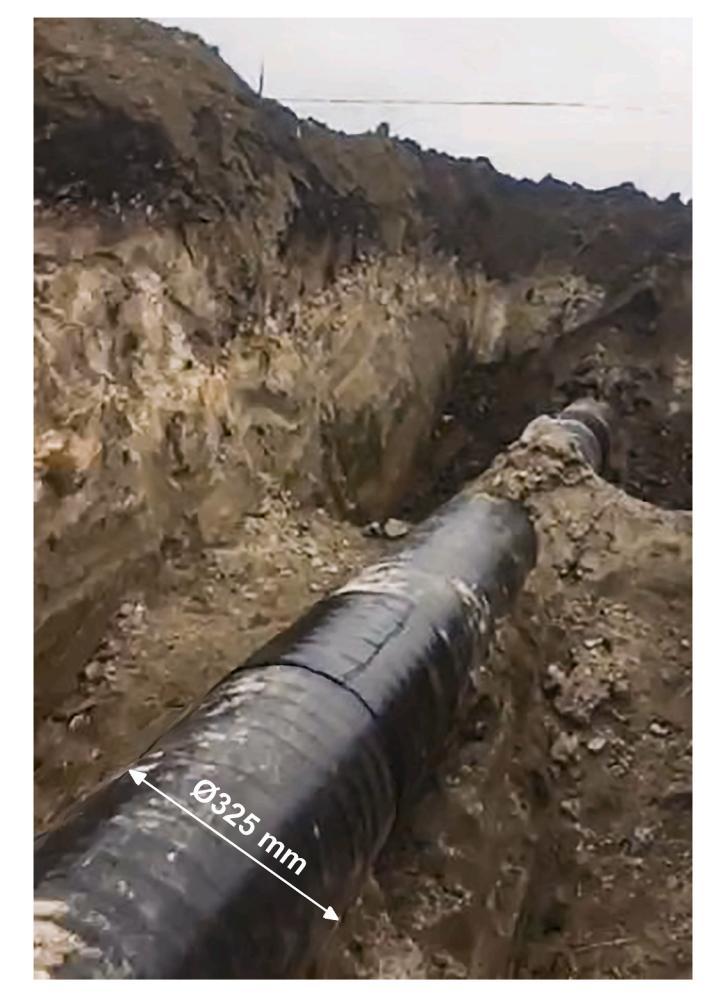
Fig. 1. Inspected site with a defective pipe.

The object of research is a section of longitudinal electric-welded pipe in the gas pipeline laid underground with the outer diameter of 325 mm and a nominal wall thickness of 8.0 mm. It was operated for more than 25 years and displayed some delamination-type defects (see Fig. 1).

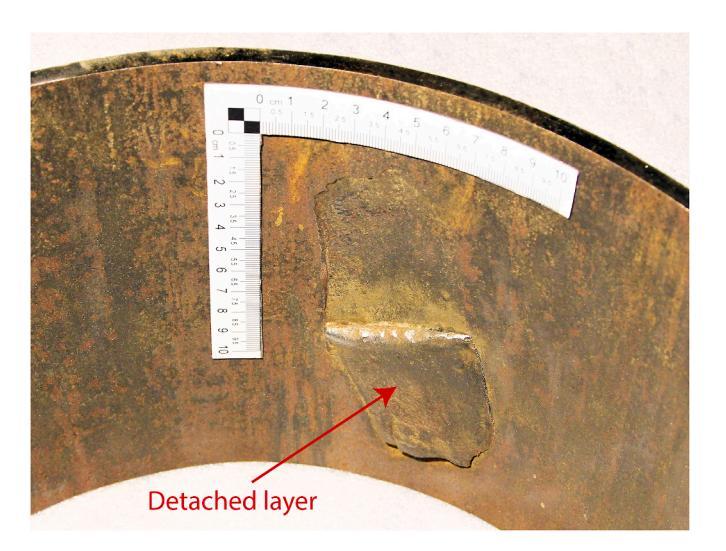
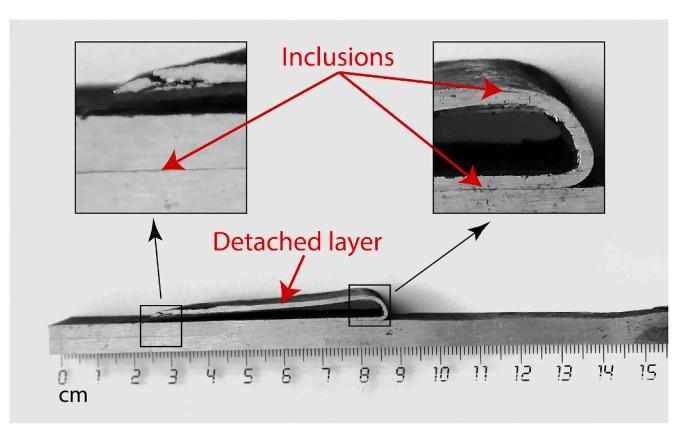
Fig. 2. Delaminated fragment cut out from the pipe.

Fig. 3. Delaminated fragment cut out from the pipe.

fragment of metal delaminated on the inner surface. This delaminated fragment was detected during intelligent pigging; moreover, it was deformed by the pigs (Figs. 2 and 3). The gas pipeline was operated under standard settings with the internal pressure up to 7.5 MPa and inspected with a certain frequency specified by the federal laws of the Russian Federation and PJSC Gazprom standards.

Such flaws were found not very often, so they had no sufficient criteria for identification. The width of the bent metal part was approximately 40 mm with the thickness from 1.0 to 1.5 mm; the bending of the detached part might have been caused by the cleaning scrapers.

Delamination-type flaws were not detected on the outer pipe surface. On the inner surface, the delaminated section 40 mm wide and 80 mm long is bent along the gas flow (Figs. 2 and 3).

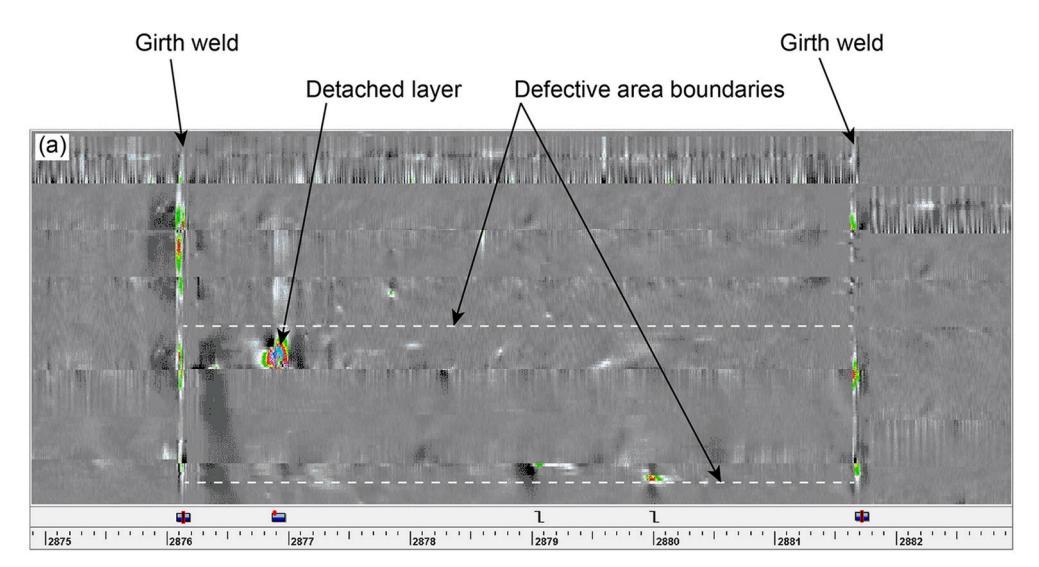
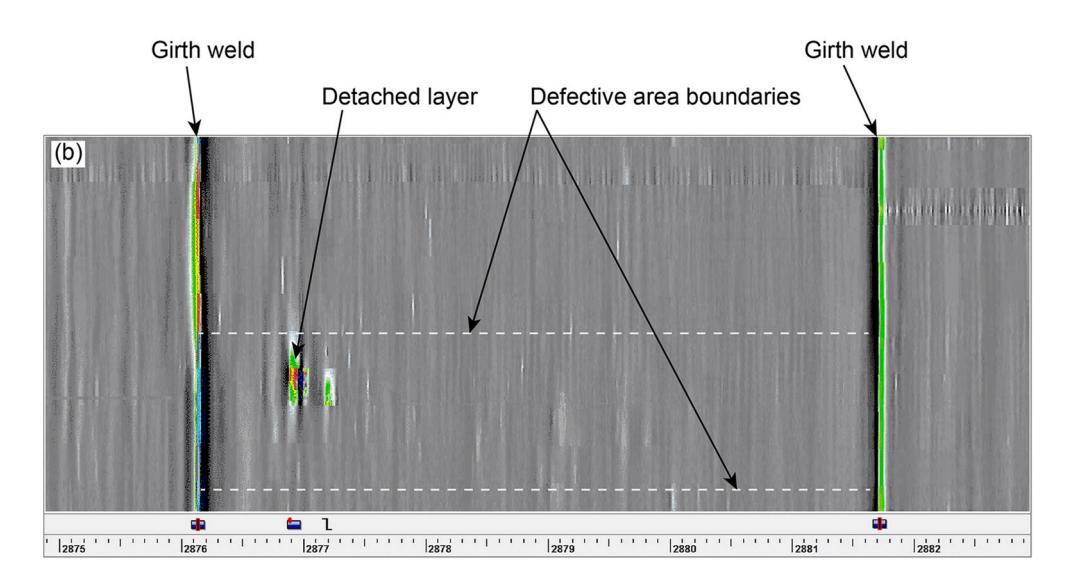
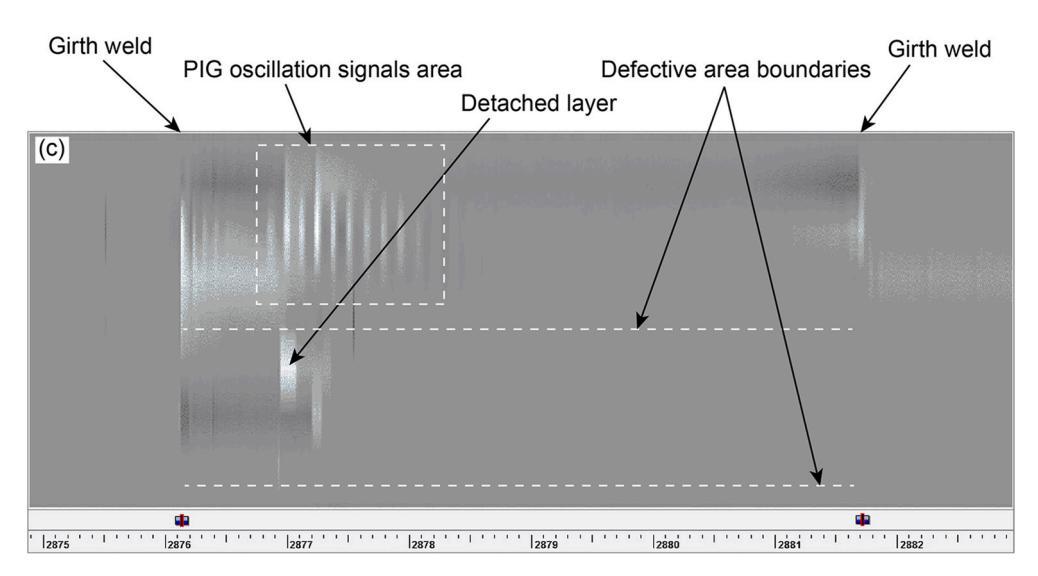
The readings of geometry pig were not matched with the anomalies, since there were no clear evidences of changes in the pipe geometry, and the deviations might have been caused by other factors.

Nevertheless, an obvious diagnostic indicator was obtained when comparing the actual physical configuration of the inner pipe surface after cutting out, the magnetograms from transversal (Fig. 5a) and longitudinal (Fig. 5 b) magnetization with the visualization of the results of geometry pigging (Fig. 5 c), which demonstrated oscillatory movements in the defective zone. Based on the intelligent pigging data this indicator makes it possible to classify clearly the defective zone as a metal delamination on the inner surface accompanied by bending of the detached fragment.

Fig. 5. Results of intelligent pigging (a – magnetogram of the transversal magnetizing pig, b – magnetogram of the longitudinal magnetizing pig, c – visualization of the geometry pig data).

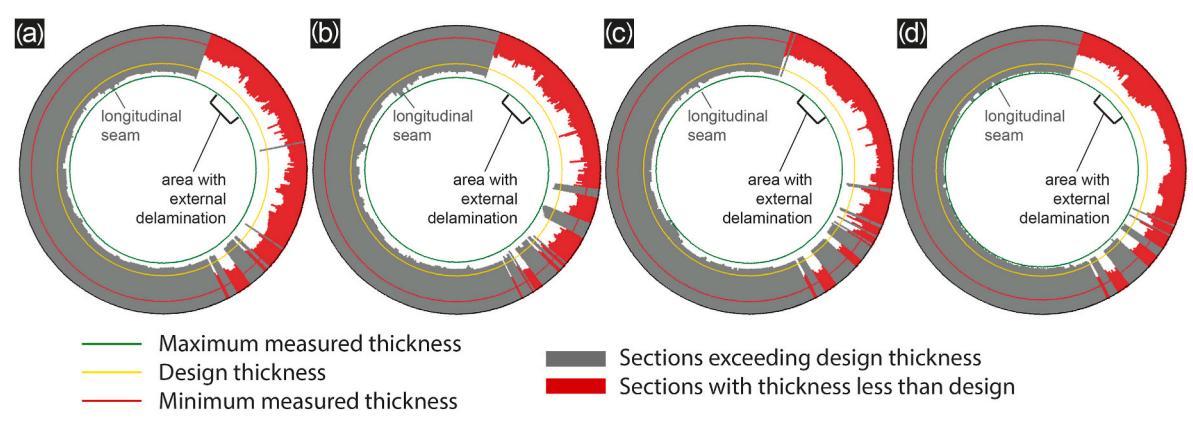
The stepwise ultrasonic measurement of thickness was carried out with a step of 2 mm on the entire pipe perimeter over the section with a visible delamination (Fig. 6) and over the adjacent zone at the distance of 300 mm (Fig. 7). The thickness measurement diagrams were plotted to demonstrate the cross-section of the pipe profile. The results revealed that the distribution of multiple flaws along the height of the pipe wall does not allow the presence of delaminations emerging on the inner surface to be to identified with a high degree of certainty. Reflection of signals from overlying flaws does not make it possible to determine the presence of underlying defects or determine the wall thickness containing inclusions. In this case a slightly higher defectiveness degree of a pipe sector with surface delaminations can be determined indirectly. In the zone without surface delaminations there are points with measurements passing the entire wall thickness (Fig. 7). Since delamination defects throughout the wall thickness were not detected by the magnetic pig-assisted method, a surface delamination inside the pipe can be found only by the radiographic testing without the direct access to the inner surface. However, this testing will reveal defects only with the clear

Fig. 6. Results of stepwise thickness measurements above the zone with external delamination (a, b, c, d – thickness measurement diagrams from ultrasonic sensors 1, 2, 3, 4, respectively).

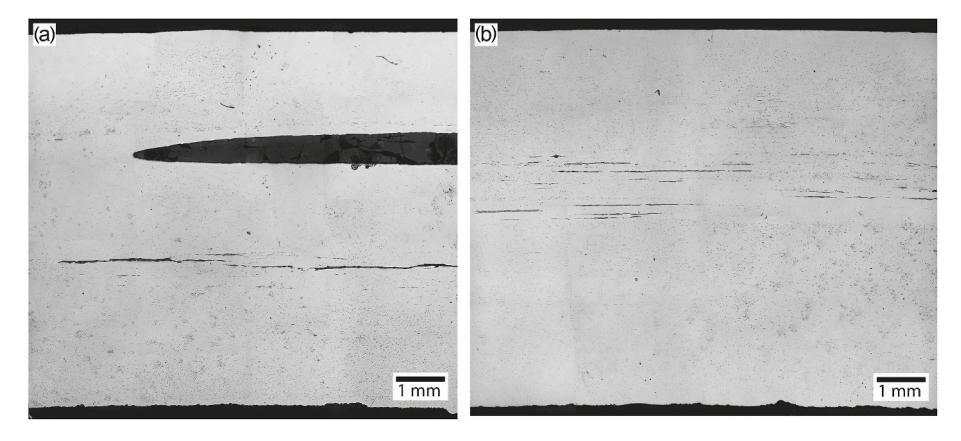
Fig. 8. Optical microscopy of defective zones before etching (a – with significantly thick flaws, up to 1 mm; b – with numerous rolled defects, up to 5 µm thick).

The microstructure of the base metal in samples was analyzed. Multilevel, extended delaminations of various thicknesses were found when examining microsections without etching (Fig. 8).

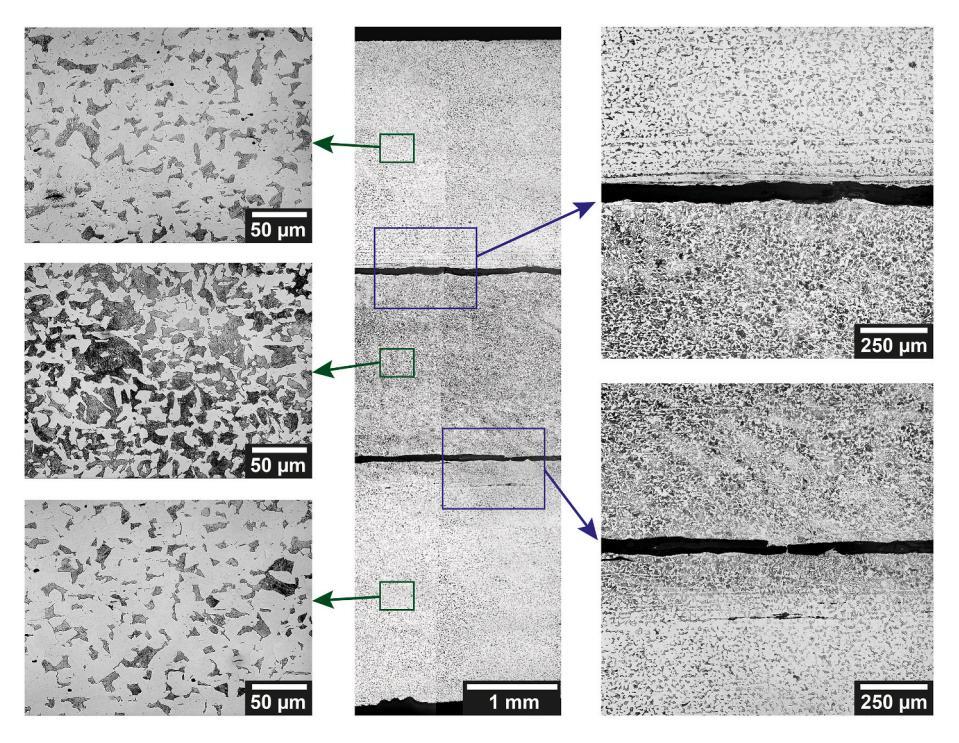
The defective pipe section exhibits inhomogeneous ferrite-pearlite structure in layers (Fig. 9), moreover, there are delaminations with

Fig. 9. Optical microscopy of the defective zone with parallel inclusions up to 50 µm after etching.

inclusions from 10 μ m to 1 mm in the pipe body. The structure of the defect-free zone has a ferrite-pearlite structure, homogenous throughout the wall thickness, which is typical for low-alloyed hypoeutectoid steels. When determining an amount of carbon by the Rosiwal method during the phase composition analysis, it was established that the percentage of pearlite amounted to 23 ... 28% in the defect-free pipe zone, it corresponds to 0.184 ... 0.216% of carbon and accords with the steel grade given in the certificate (steel 20 specified by GOST 1050-88). Nearly the same amount of pearlite was detected at the depth of 2–3 mm from both sides of the outer wall surface in the defective pipe. Along the axis of the flaw part there were different structurally inhomogeneous zones, including a stripe-like structure, accumulations of up to three-four ferrite layers and zones with a higher concentration of pearlite. The volume of the pearlite phase, determined by the Rosival method, in such areas reaches 60%, which corresponds to 0.48% of carbon, and goes

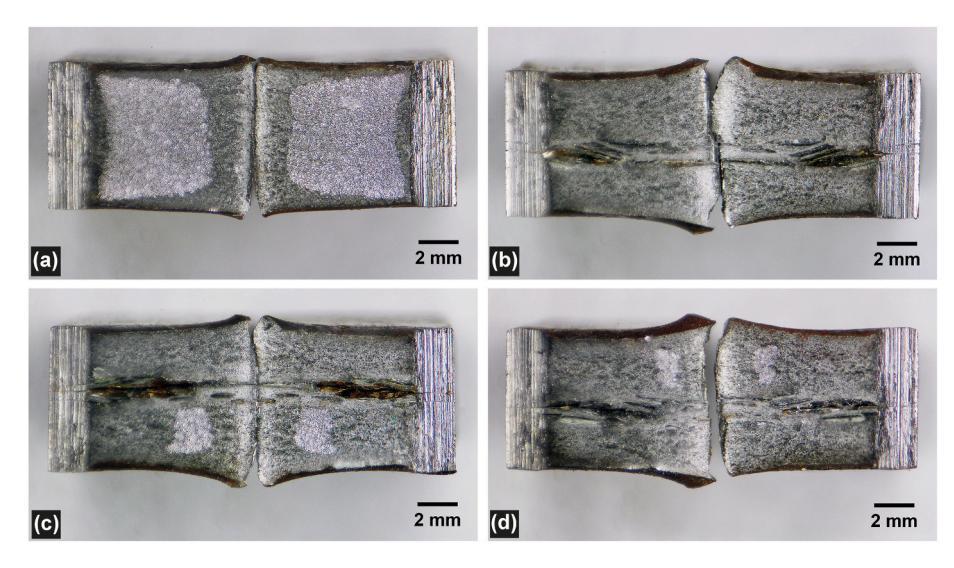
Fig. 10. Macrophotography of fractures in samples (a - defect-free sample, b, c, d - samples with internal flaws).

Defect-free samples in the analysis of fractures showed a characteristic fracture structure for low-carbon steels (Fig. 10 a). The surface has a viscous fibrous zone and a brittle zone, as well as a rupture area on the opposite side of the zone adjacent to the notch and shear lips on the edges of samples.

heterogeneity of surfaces and a reduced or even non-existent brittle rupture zone. The defective zones in the form of thin longitudinal inclusions significantly increased the impact toughness. The samples with inclusions demonstrate a reduced (Fig. 10 c, d) or non-existent (Fig. 10 b) brittle rupture zone.

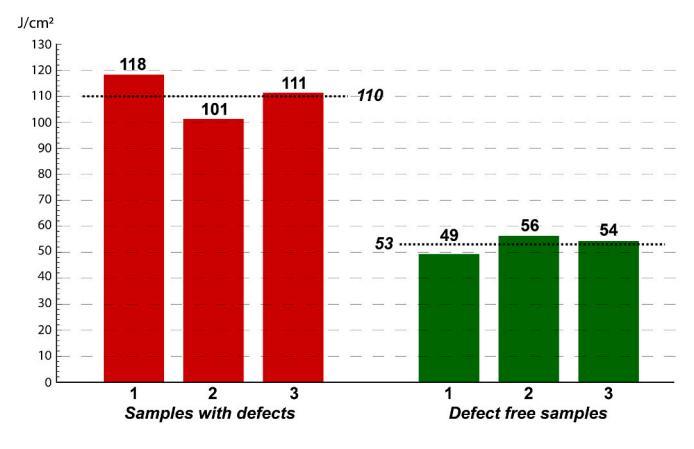
Fig. 11. Results of samples testing.

Inner discontinuities with the maximal thickness up to 50 μ m, which are not connected with each other, caused a significant increase in viscous component during testing. An average value of impact toughness in defective samples was almost twice higher that in the defect-free ones (Fig. 11).

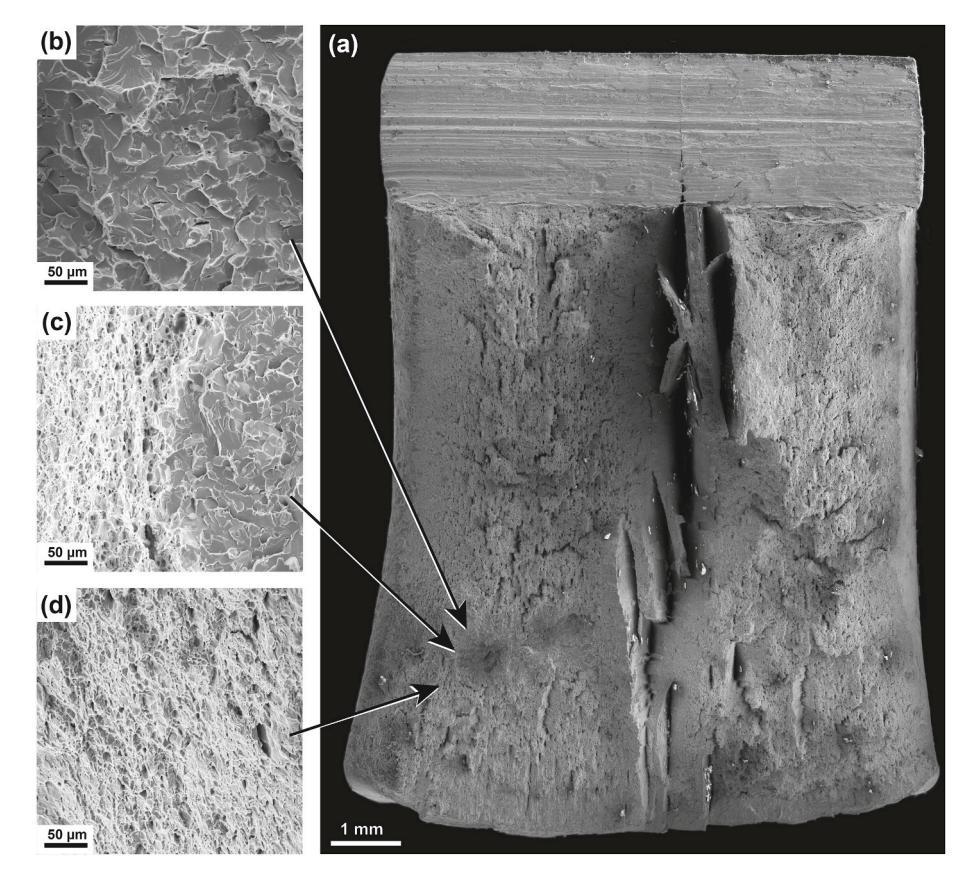
Fig. 12. The defective sample surface after impact toughness tests (a – surface appearance; b – zone of brittle rupture; c – zone with the brittle and viscous fracture boundary; d – zone of viscous fracture).

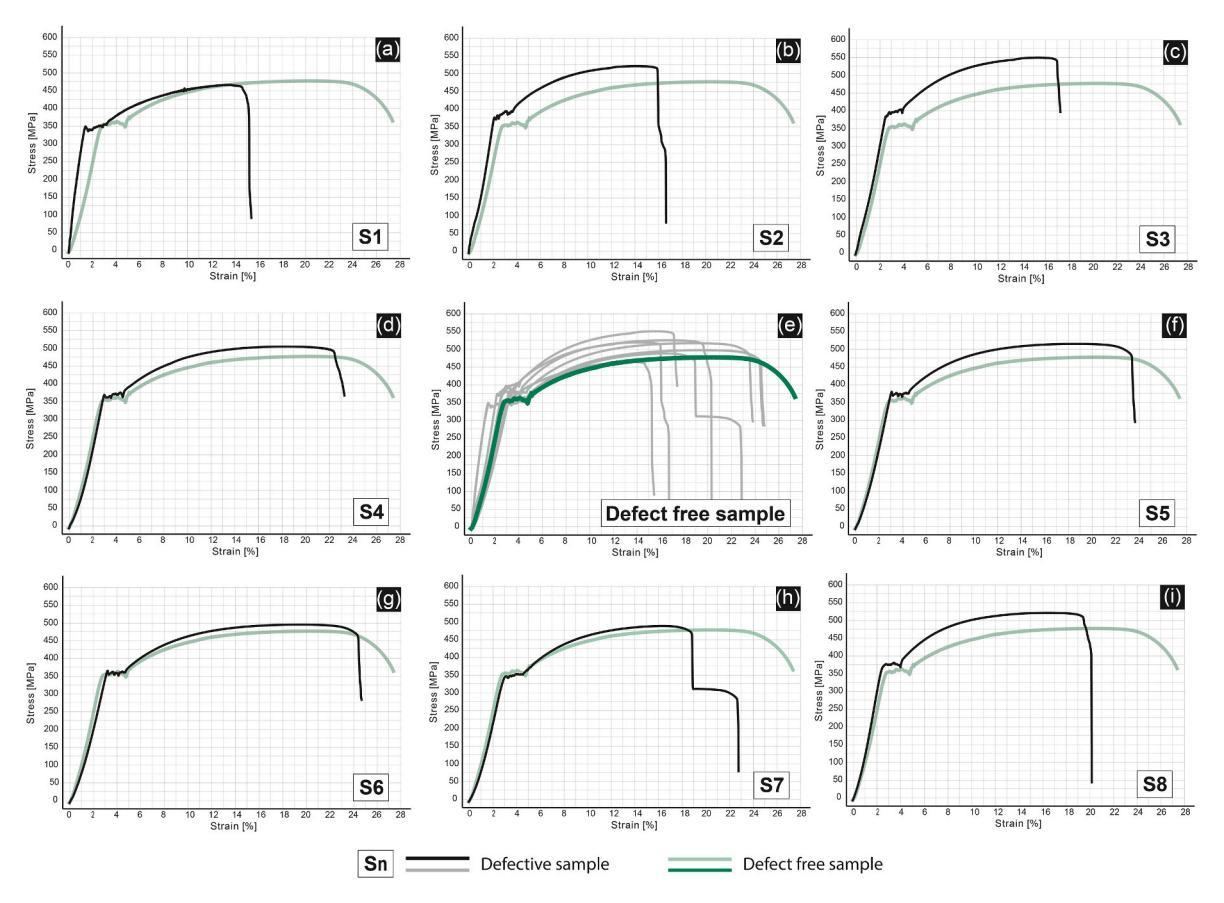
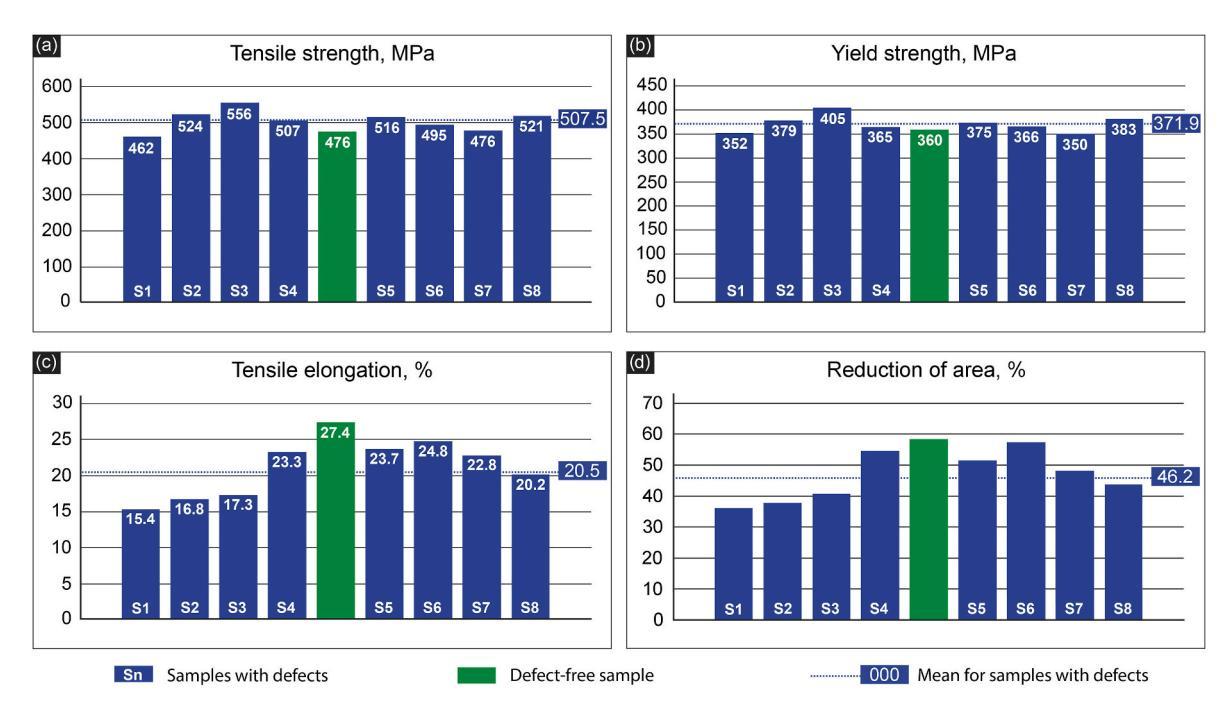
Fig. 13. Tension diagrams based on the test results (a-d, f-i – test results of defective samples in comparison with the flaw-free ones; e – test results of the defect-free sample).

Fig. 14. Consolidated test results (a - tensile strength; b - yield strength; c - tensile elongation, d - reduction of area).

Static rupture tests (Figs. 13 and 14) were carried out using 11 prepared samples. Eight samples were cut out of defective zones, and three samples were taken from a defect-free zone. The test results of defect-free samples demonstrated slightly different parameters, which characterize low-carbon pipe steels; the deviations were within a statistical error and did not exceed 1.5%. An averaged result was taken as a

Defective samples fracturing showed that the metal properties changed significantly because of the chemical heterogeneity and inner interfaces. The tensile strength and the yield strength slightly increased by 6.6% and 3.3%, respectively. Flaws had the strongest effect on tensile elongation which decreased by 25.2% on average.

All samples except for S1 demonstrated a slightly increased tensile strength if compared with the flaw-free samples. Sample S1 exhibited a decreased tensile strength due to deeper, up to 0.5 mm, inclusions found throughout the wall thickness, this fact reduced a real area of the material under study.

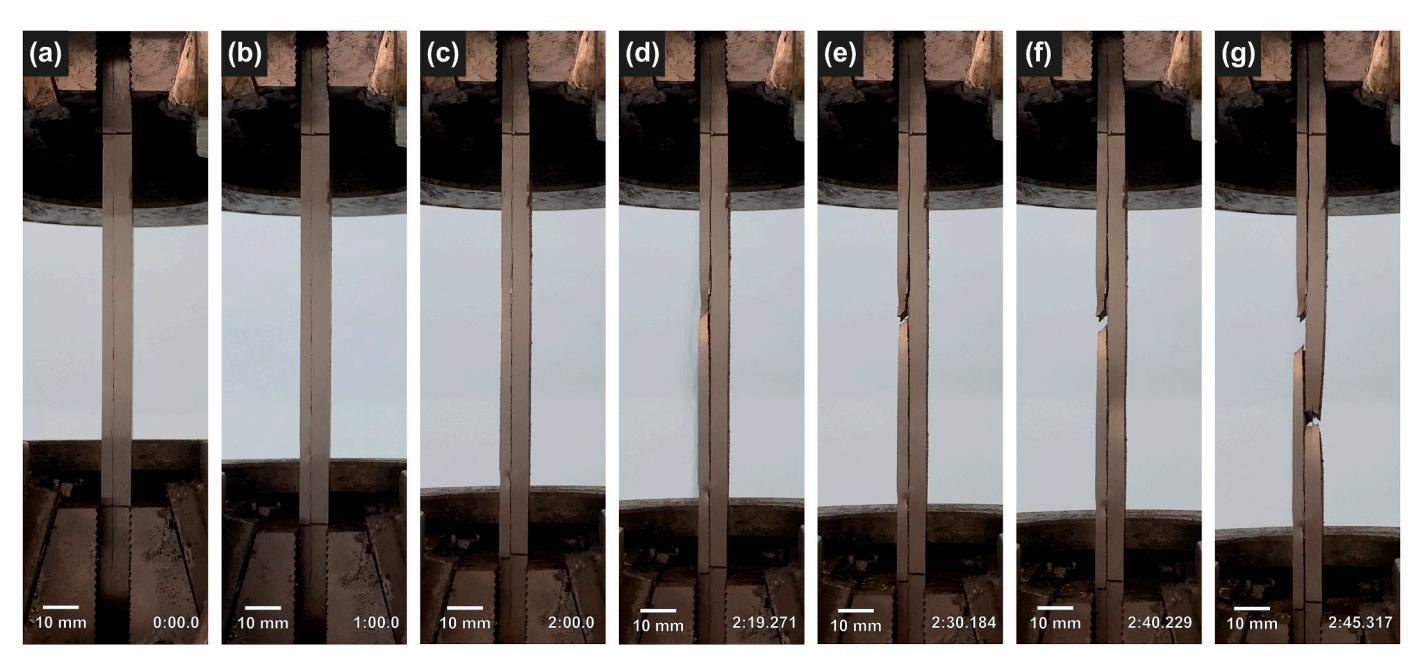
Fig. 15. Fracture dynamics of sample S7 containing layers with different characteristics.

The effect of defects was most pronounced on the sample S7 (Fig. 15), where the material during testing was divided into two zones, with significantly different characteristics and rupture points distant from each other. The sample also clearly shows an additional area of thinning of the layer fractured first and located in the lower part of the sample.

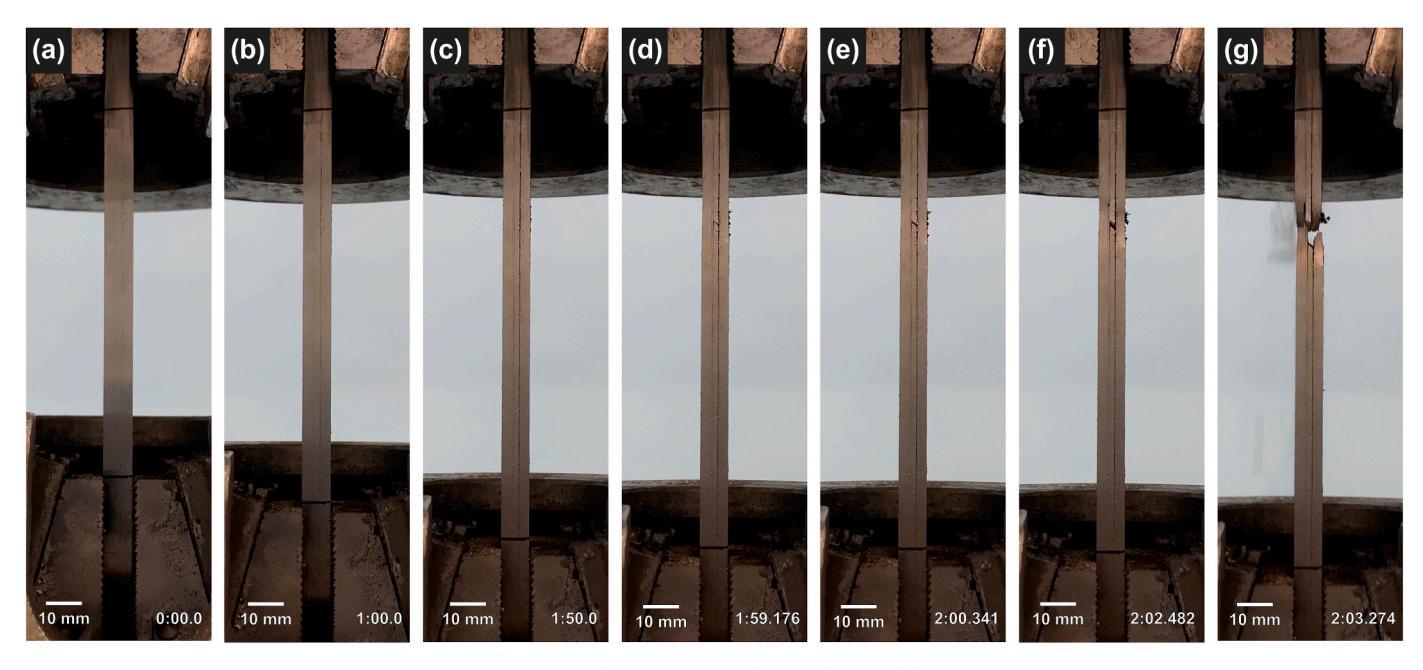
Fig. 16. The fracture dynamics of sample S8 with inner delaminations.

The other samples demonstrated almost similar fracture dynamics: separation into layers and their nearly simultaneous fracture. The typical model of fracture dynamics is presented on the example of sample S8 (Fig. 16). The sample has one visible extended layer. However, defects located along the same axis during elongation merge and additional defective lines are revealed (see Fig. 17).

The middle part of a sample fractured (Fig. 16d) but edge parts bear load for some period of time and resist fracture. The final fracture zone is detected nearly on the same level (Fig. 16 g).

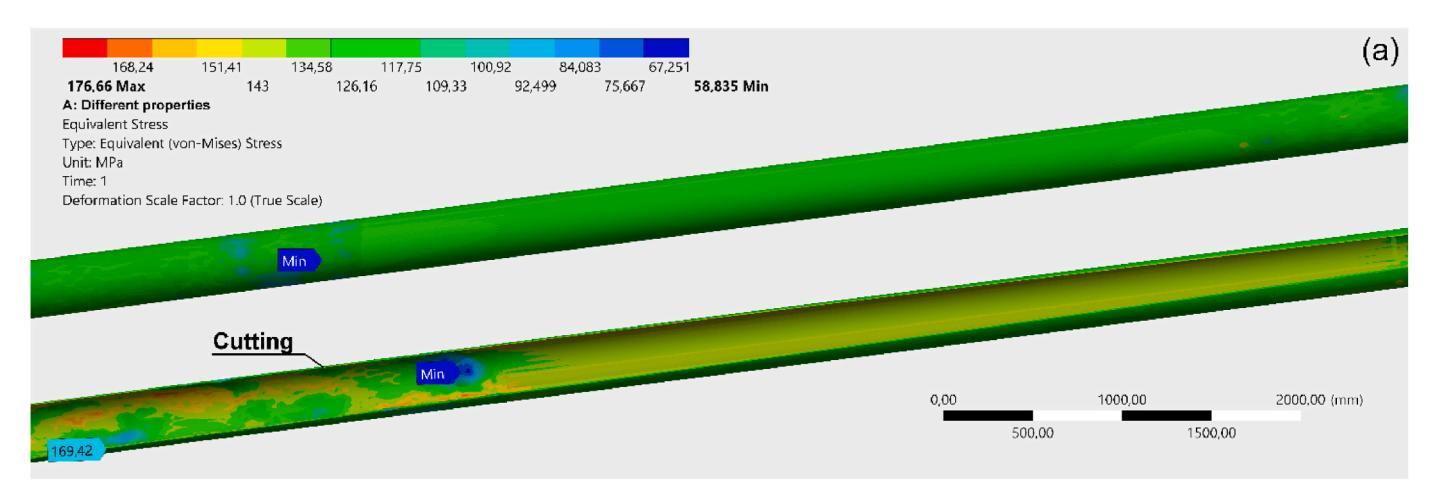
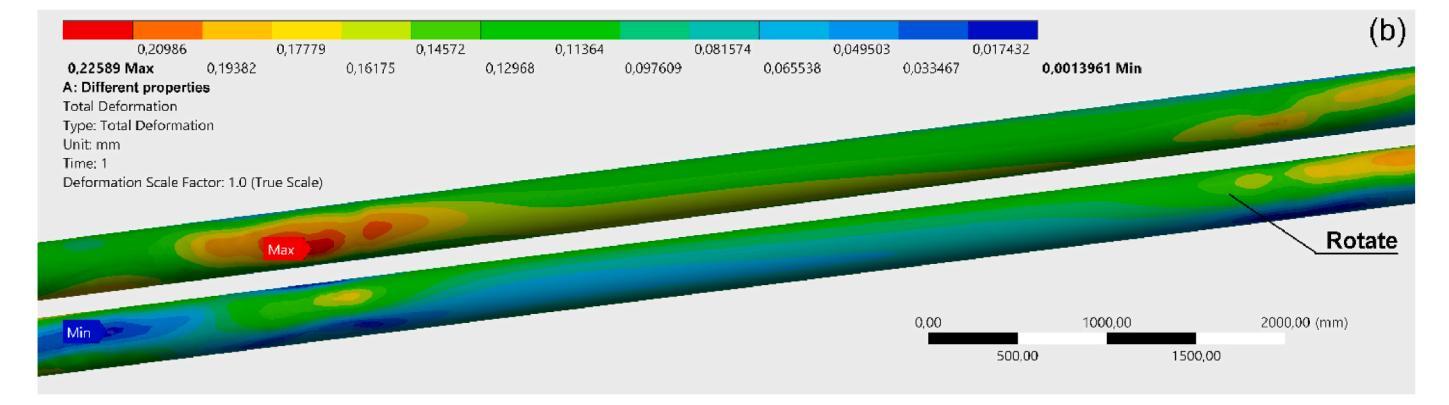
Fig. 19. Modeling of a pipe section consisting of parts with different properties (a - equivalent stress; b - total deformation).

The safety factor of the defect-free section will be 2.59, of the defective section 2.04. Based on the modeling results, it was found that the presence of parts with different physical and mechanical properties of the metal in one pipe leads to a violation of the uniform distribution of stresses and deformation not only in it, but in adjacent areas as well. At the same time, the maximum stresses reaching 176.66 MPa (27% higher than in the defect-free section) occur on the pipes adjacent to the defective one. Sections containing pipes with heterogeneous physical and mechanical properties have a significantly lower margin of safety during operation, in the case under consideration, by 20%.
