International Journal of Pressure Vessels and Piping

Specifics of diagnostics and investigation of material properties in pipes with planar defects

Dmitrii Zhukov^{a,b,c}, Sergey Konovalov^{a,c,d,*}, Danhe Chen^a, Alexey Melnikov^c, Irina Panchenko^d

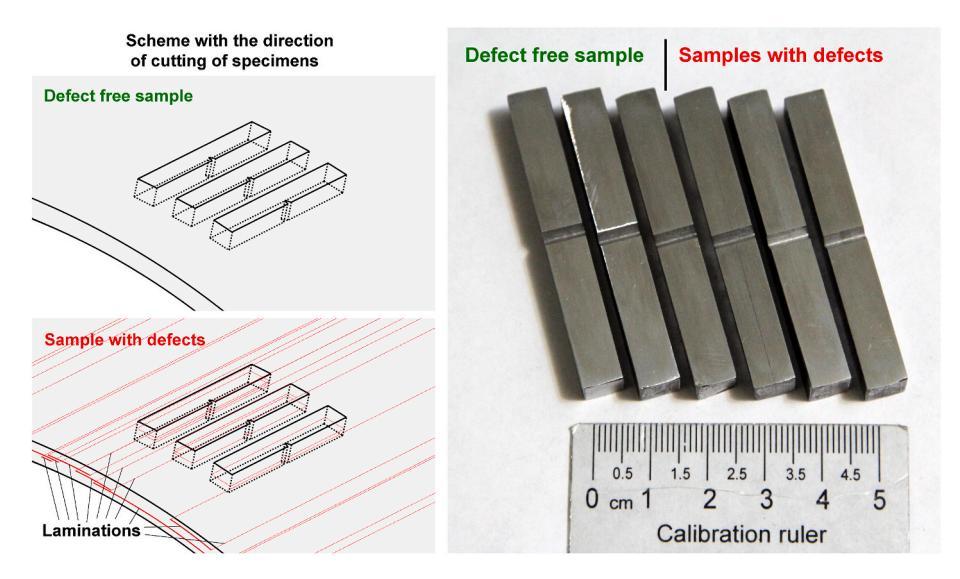
Fig. 4. Samples prepared for impact toughness tests.

The impact toughness was measured by Charpy V-notch test according to GOST R ISO 148-1-2013 "Metallic materials. Charpy pendulum impact test. Part 1. Test method". Three samples with sizes $55 \times 7 \times 10$ mm cut out of defect-free zones and three samples cut out of sections with flaws (Fig. 4) were tested.

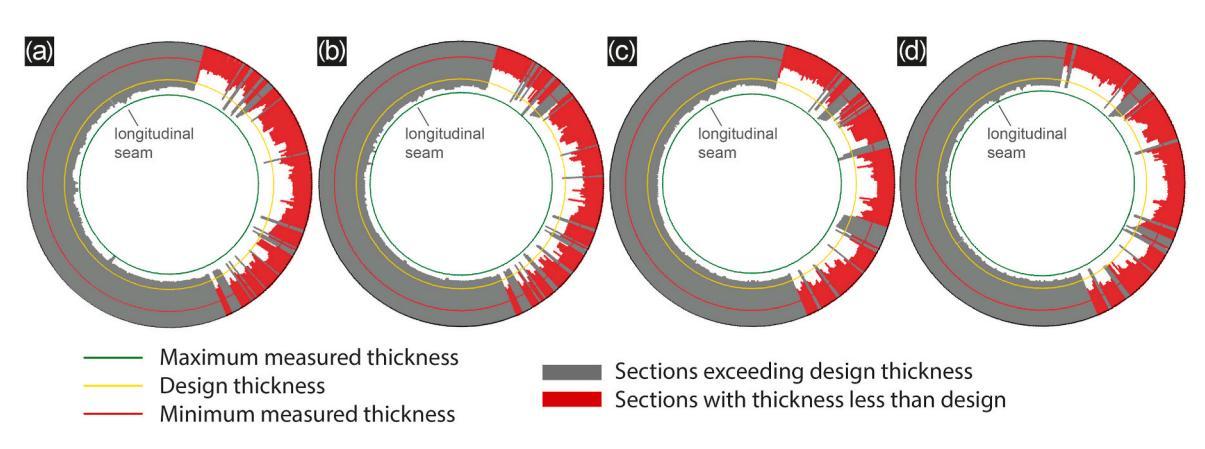
The stepwise ultrasonic measurement of thickness was carried out with a step of 2 mm on the entire pipe perimeter over the section with a visible delamination (Fig. 6) and over the adjacent zone at the distance of 300 mm (Fig. 7). The thickness measurement diagrams were plotted to demonstrate the cross-section of the pipe profile. The results revealed that the distribution of multiple flaws along the height of the pipe wall does not allow the presence of delaminations emerging on the inner surface to be to identified with a high degree of certainty. Reflection of signals from overlying flaws does not make it possible to determine the presence of underlying defects or determine the wall thickness containing inclusions. In this case a slightly higher defectiveness degree of a pipe sector with surface delaminations can be determined indirectly. In the zone without surface delaminations there are points with measurements passing the entire wall thickness (Fig. 7). Since delamination defects throughout the wall thickness were not detected by the magnetic pig-assisted method, a surface delamination inside the pipe can be found only by the radiographic testing without the direct access to the inner surface. However, this testing will reveal defects only with the clear

Fig. 7. Results of stepwise thickness measurements above the zone without external delamination (a, b, c, d – thickness measurement diagrams from ultrasonic sensors 1, 2, 3, 4, respectively).

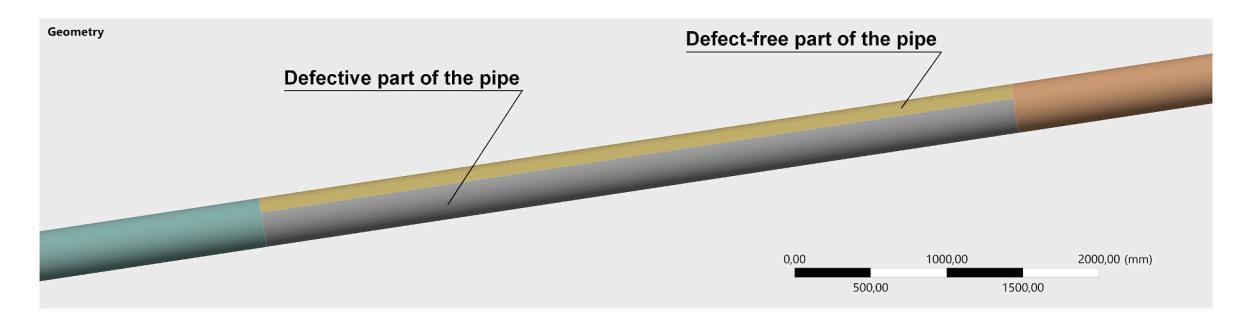
Fig. 17. Geometry of the modeled section.

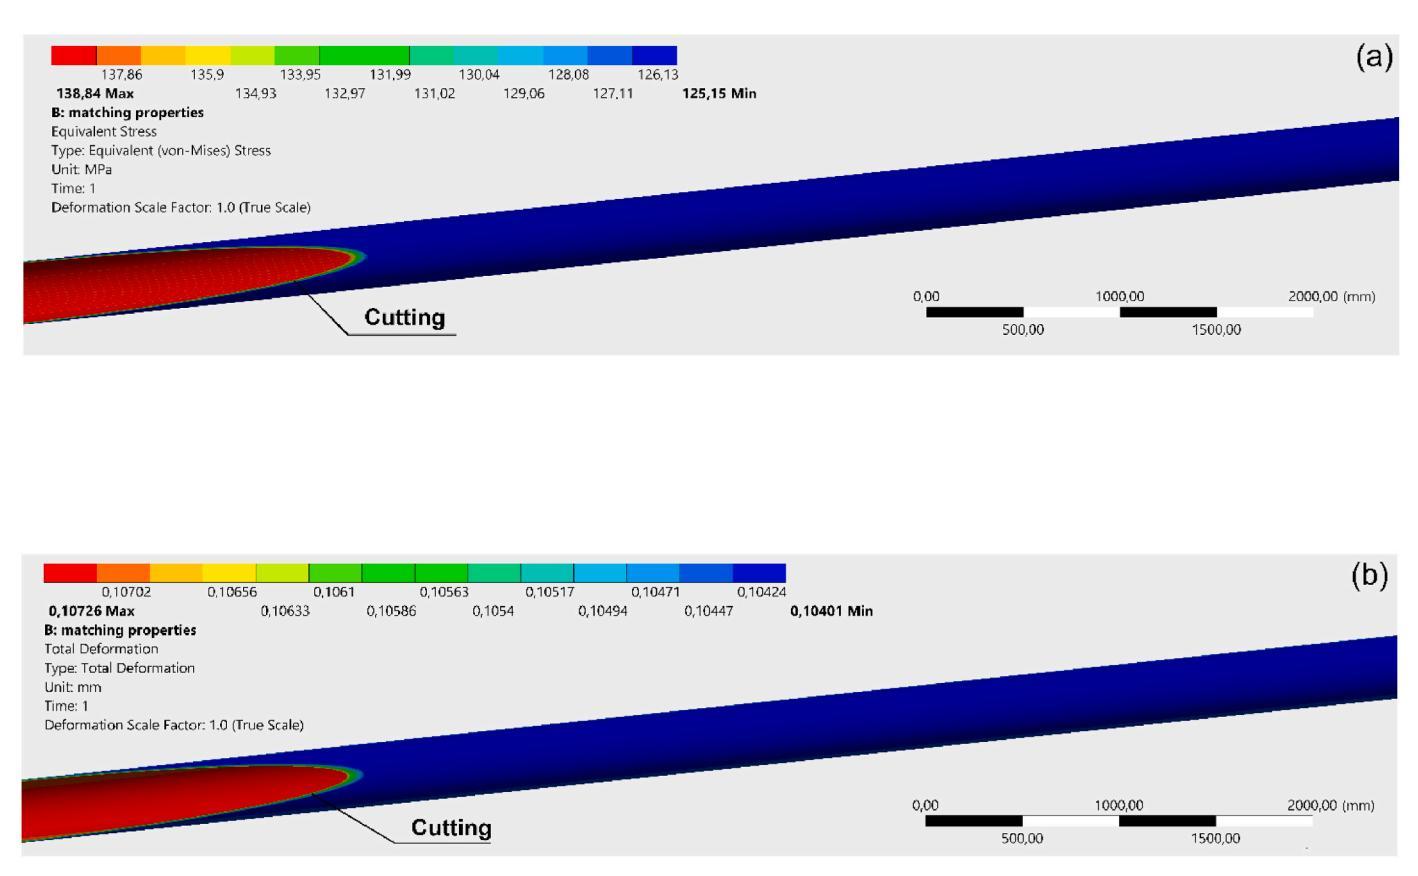
Fig. 18. Defect-free section (a - equivalent stress; b - total deformation).

Modeling conditions	Maximum values		Minimum values		Range	
	Stress, MPa	Deformation, mm	Stress, MPa	Deformation, mm	Stress, MPa	Deformation, mm
Defect-free (Fig. 18) Defective pipe section without internal flaws (Fig. 19)	138.84 176.66	0.10726 0.22589	125.15 58.835	0.10401 0.001396	13.69 117.825	0.00325 0.224494
